# Columbia: A Tragedy Repeated

By Gary Johnson

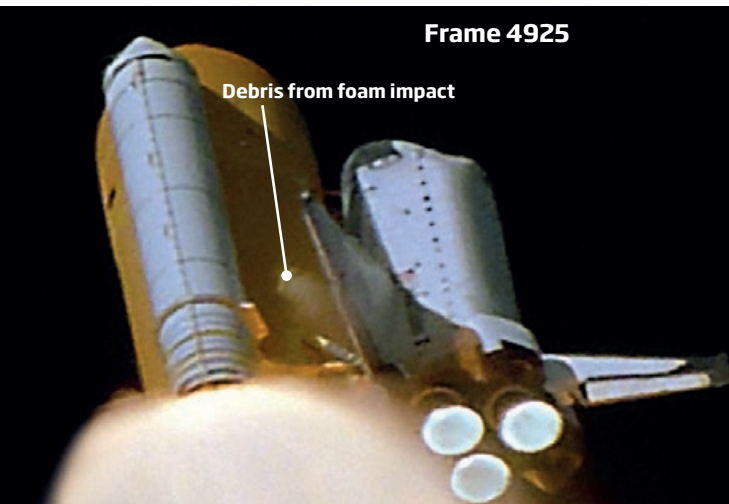
Frame 4925

Debris from foam impact

*A color enhanced, de-blurred still frame of the foam strike, derived from video recording. Credits: NASA*

The Space Shuttle Columbia STS-107 was launched on January 16, 2003 at 10:39 a.m. Eastern Standard Time. At 81.7 seconds after launch, when the Shuttle was at about 20,000m and traveling at Mach 2.46 (2,655km/h), a large piece of insulating foam came off the External Tank (ET) left bipod ramp area, close to where the orbiter attaches to the ET. The foam impacted under the leading edge of the left wing at 81.9 seconds. This incident was not seen by anyone on the ground or in the Kennedy Space Center (KSC) Firing Room or Johnson Space Center (JSC) Mission Control Center (MCC); there was no onboard indication to the crew. The impact was detected the next day during the detailed review of all launch camera photography that is conducted after every Shuttle launch. The analysis revealed that the debris was approximately 53-68cm long and 30-45cm wide, tumbling and moving at a

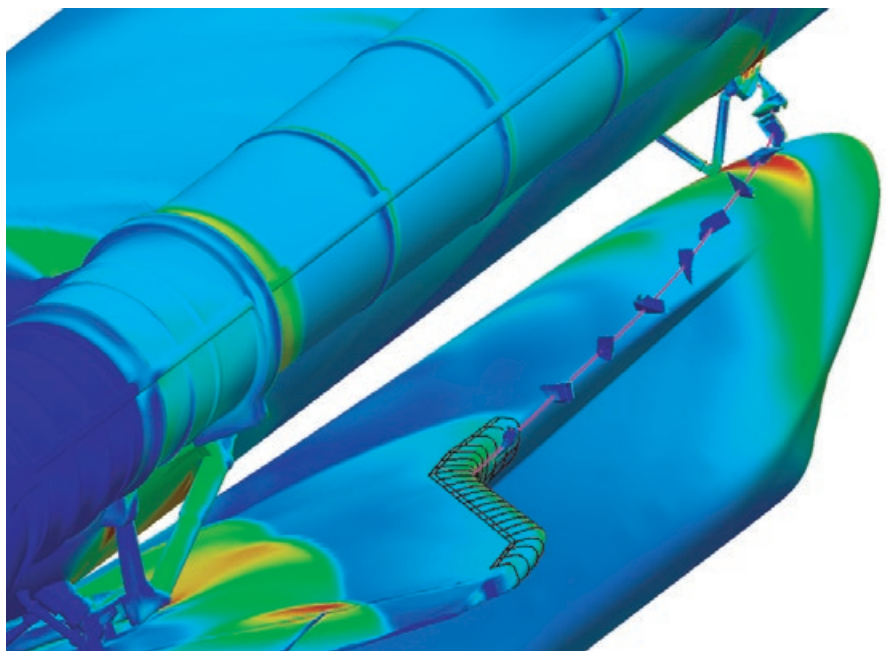
*A trajectory analysis that used a computational fluid dynamics approach to determine the likely position and velocity histories of the foam. Source: CAIB Report, p 61*

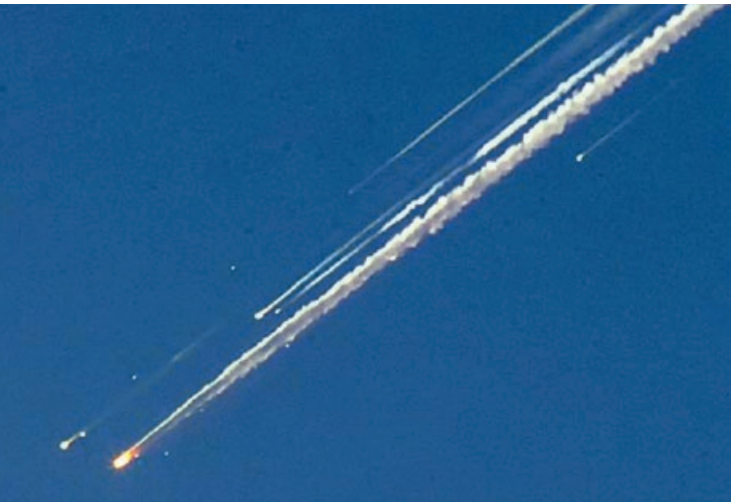
According to CAIB, destruction of the crew module took place over a period of 24 seconds, beginning at an altitude of approximately 42,672m and ending at 32,000m. Credits: NASA

aero-thermal loads resulted in the total destruction of the crew module and forebody by EI+1021s. From data and analysis it appears that the destruction of the crew module took place over a period of 24 seconds, beginning at an altitude of approximately 42,672m and ending at 32,000m. The death of the crew was due to blunt force trauma and hypoxia (Ref [1] pp 70-77; [2] pp 1-63, 72).

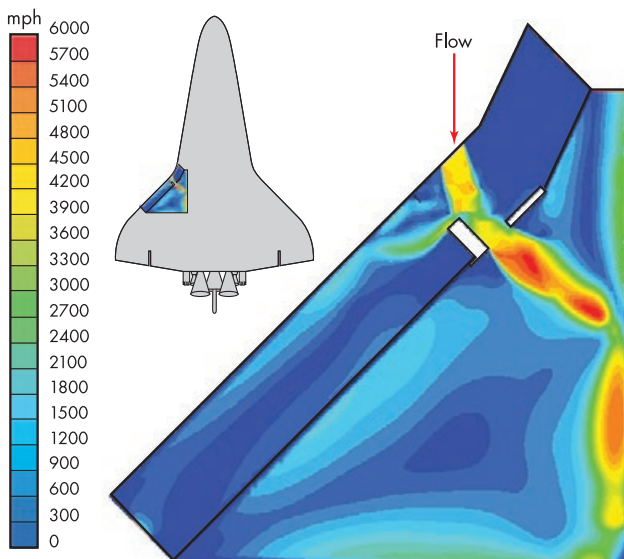
Columbia reentered the atmosphere with a breach in the Reinforced Carbon-Carbon (RCC) left wing leading edge near Panel 8. This breach allowed super-heated air, estimated to be about 2,760°C, to penetrate behind the TPS, destroying the insulation that protected the leading edge support structure and melting the aluminum wing spar. This resulted in thermal degradation of structural properties of the left wing. At Entry Interface (EI) plus 555 seconds, video from the ground shows pieces of material shedding from the orbiter, which continued to fly its pre-planned flight profile. Later, over the Dallas-Fort Worth, Texas area at about 60,960m, the increasing aerodynamic forces caused catastrophic damage to the left wing. At EI+613s, when the super-heated air had penetrated to the outside of the left wheel well, and destroyed the four hydraulic sensor electrical cables, controllers on the ground saw the first anomalies in telemetry data. At EI+727s, Mission Control noted an increase in left wheel well hydraulic line temperatures. At EI+790s, the two left main gear outboard tire pressure sensors began trending upward, then off-scale low. At EI+834s, a sharp change in the rolling tendency of the orbiter occurred along with additional shedding of debris. In an attempt to maintain attitude control, the orbiter responded with a sharp change in aileron trim, likely due to wing deformation. At EI+917s, the data ▶▶

Computational fluid dynamics analysis of the speed of the superheated air as it entered the breach in RCC panel 8 and travels through the wing leading edge spar. The darkest red color indicates speeds of over 6,400 km/h; temperatures likely exceeded 2,760 degrees Celsius. Source: CAIB Report, pag 69

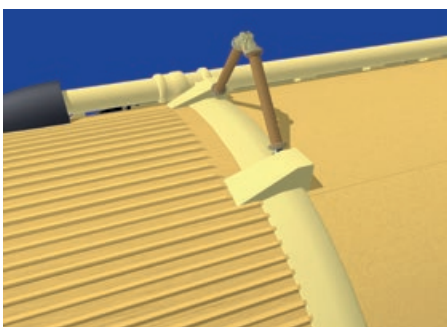
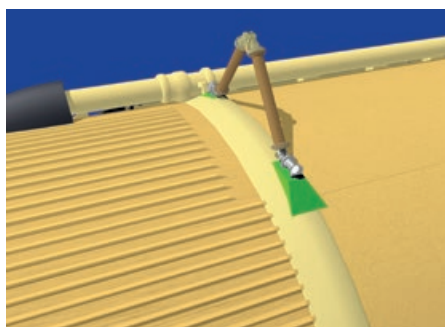
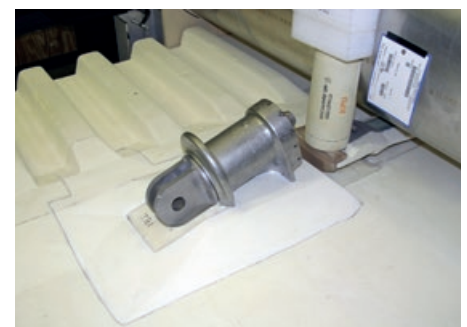
*Left: the External Tank's bipod fittings covered by foam ramps, as flown on the Space Shuttle Columbia. Center and right: the redesigned fitting.  
Credits: Lockheed Martin/NASA Michoud*

The Space Shuttle was grounded following the loss of Columbia and did not return to flight until July 26, 2005. In the intervening two and a half years, the ET TPS was re-designed and capabilities for detecting an impact were installed: video cameras on the solid rocket boosters and ET feedline, high speed cameras at the launch site, aircraft mounted cameras and radar, and an impact sensor mounted on the backside of the wing's RCC and nose cap. The crew of STS-
