# Columbia: A Tragedy Repeated

By Gary Johnson

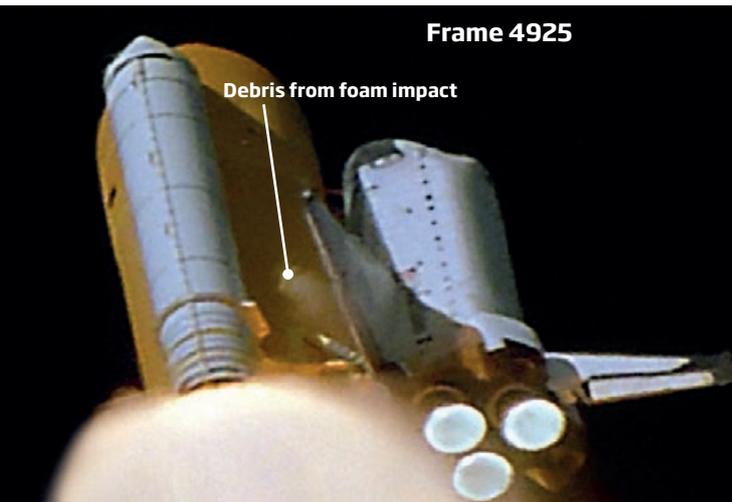
A color enhanced, de-blurred still frame of the foam strike, derived from video recording. Credits: NASA

The Space Shuttle Columbia STS-107 was launched on January 16, 2003 at 10:39 a.m. Eastern Standard Time. At 81.7 seconds after launch, when the Shuttle was at about 20,000m and traveling at Mach 2.46 (2,655km/h), a large piece of insulating foam came off the External Tank (ET) left bipod ramp area, close to where the orbiter attaches to the ET. The foam impacted under the leading edge of the left wing at 81.9 seconds. This incident was not seen by anyone on the ground or in the Kennedy Space Center (KSC) Firing Room or Johnson Space Center (JSC) Mission Control Center (MCC); there was no onboard indication to the crew. The impact was detected the next day during the detailed review of all launch camera photography that is conducted after every Shuttle launch. The analysis revealed that the debris was approximately 53-68cm long and 30-45cm wide, tumbling and moving at a

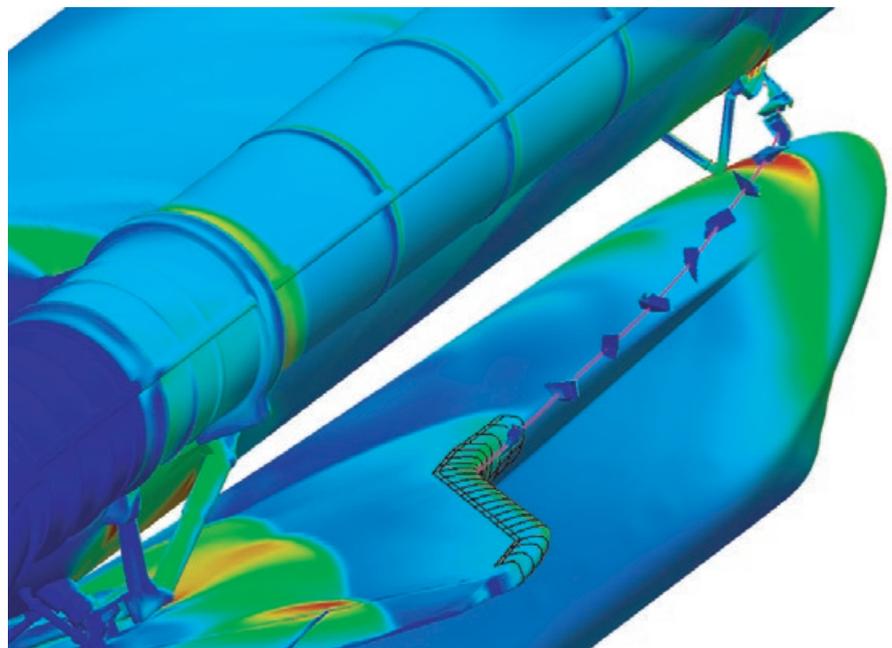
*A trajectory analysis that used a computational fluid dynamics approach to determine the likely position and velocity histories of the foam.*  
Source: CAIB Report, p 61

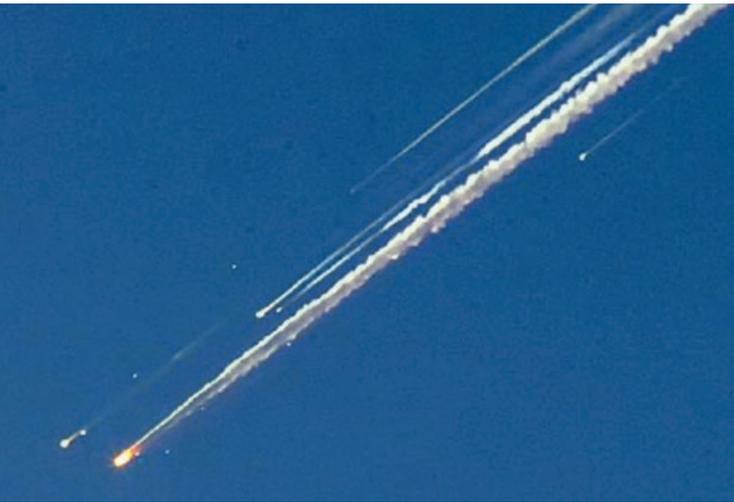
According to CAIB, destruction of the crew module took place over a period of 24 seconds, beginning at an altitude of approximately 42,672m and ending at 32,000m. Credits: NASA

aero-thermal loads resulted in the total destruction of the crew module and forebody by EI+1021s. From data and analysis it appears that the destruction of the crew module took place over a period of 24 seconds, beginning at an altitude of approximately 42,672m and ending at 32,000m. The death of the crew was due to blunt force trauma and hypoxia (Ref [1] pp 70-77; [2] pp 1-63, 72).

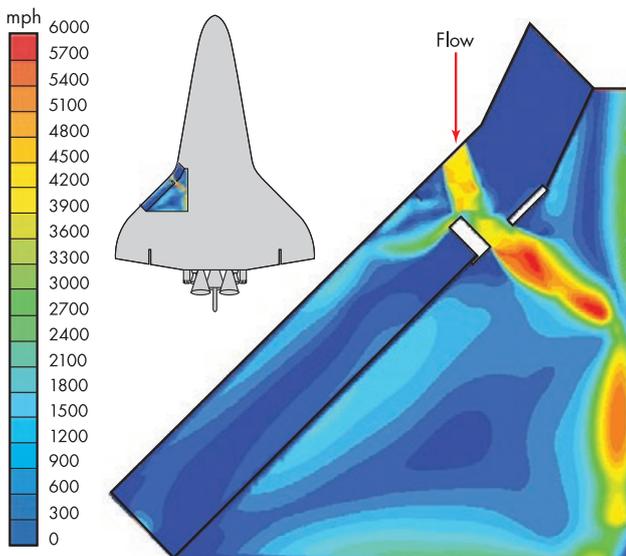
Columbia reentered the atmosphere with a breach in the Reinforced Carbon-Carbon (RCC) left wing leading edge near Panel 8. This breach allowed super-heated air, estimated to be about 2,760°C, to penetrate behind the TPS, destroying the insulation that protected the leading edge support structure and melting the aluminum wing spar. This resulted in thermal degradation of structural properties of the left wing. At Entry Interface (EI) plus 555 seconds, video from the ground shows pieces of material shedding from the orbiter, which continued to fly its pre-planned flight profile. Later, over the Dallas-Fort Worth, Texas area at about 60,960m, the increasing aerodynamic forces caused catastrophic damage to the left wing. At EI+613s, when the super-heated air had penetrated to the outside of the left wheel well, and destroyed the four hydraulic sensor electrical cables, controllers on the ground saw the first anomalies in telemetry data. At EI+727s, Mission Control noted an increase in left wheel well hydraulic line temperatures. At EI+790s, the two left main gear outboard tire pressure sensors began trending upward, then off-scale low. At EI+834s, a sharp change in the rolling tendency of the orbiter occurred along with additional shedding of debris. In an attempt to maintain attitude control, the orbiter responded with a sharp change in aileron trim, likely due to wing deformation. At EI+917s, the data ▶▶

Computational fluid dynamics analysis of the speed of the superheated air as it entered the breach in RCC panel 8 and travels through the wing leading edge spar. The darkest red color indicates speeds of over 6,400 km/h; temperatures likely exceeded 2,760 degrees Celsius. Source: CAIB Report, pag 69

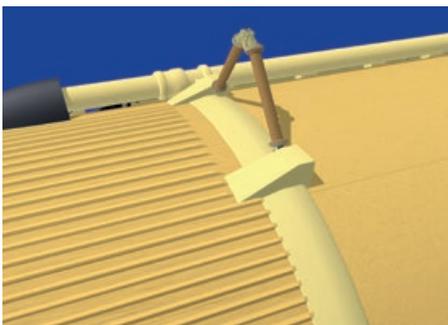
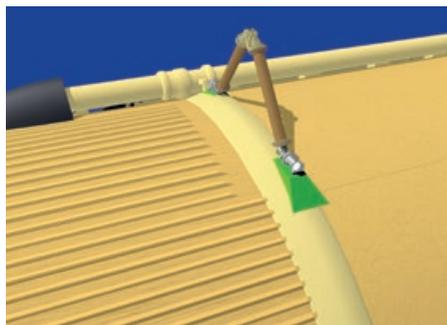
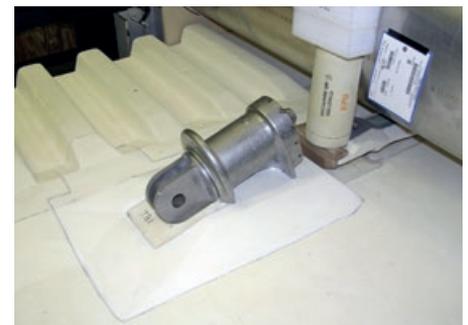
*Left: the External Tank's bipod fittings covered by foam ramps, as flown on the Space Shuttle Columbia. Center and right: the redesigned fitting.  
Credits: Lockheed Martin/NASA Michoud*

The Space Shuttle was grounded following the loss of Columbia and did not return to flight until July 26, 2005. In the intervening two and a half years, the ET TPS was re-designed and capabilities for detecting an impact were installed: video cameras on the solid rocket boosters and ET feedline, high speed cameras at the launch site, aircraft mounted cameras and radar, and an impact sensor mounted on the backside of the wing's RCC and nose cap. The crew of STS-
