# Columbia: A Tragedy Repeated

By Gary Johnson

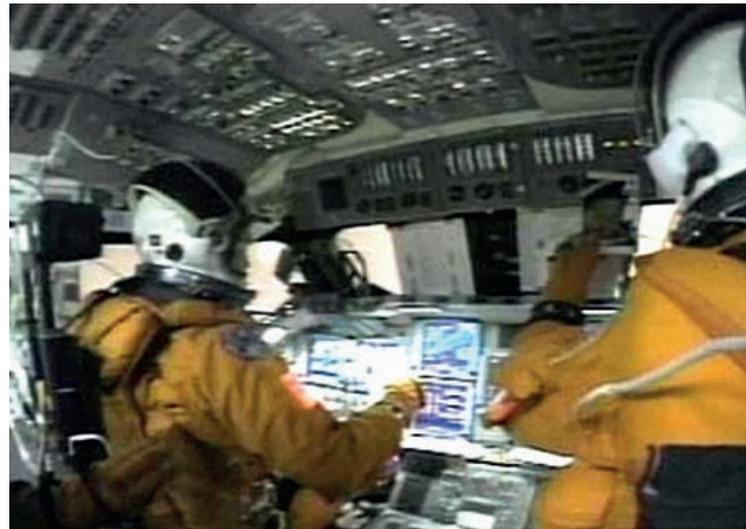
*A frame from a tape recording taken by the crew 4 minutes before the breakup.*  
Credits: NASA

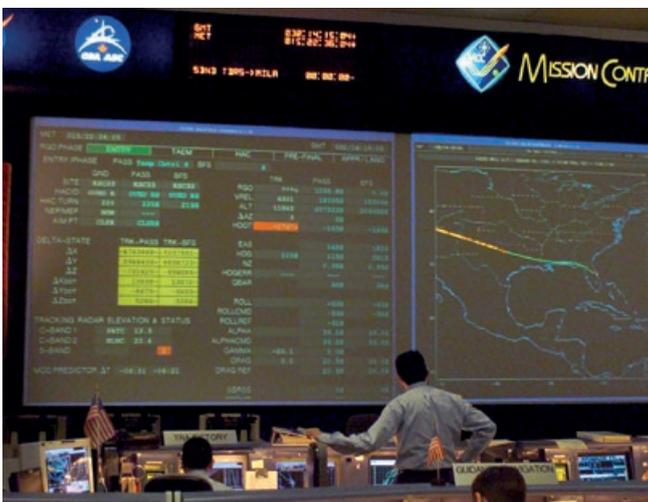
*The shuttle flight control room in Houston's Mission Control Center at JSC right after flight controllers lost contact with the Space Shuttle Columbia.*  
Credits: NASA
